MGB Ignition System Feedback

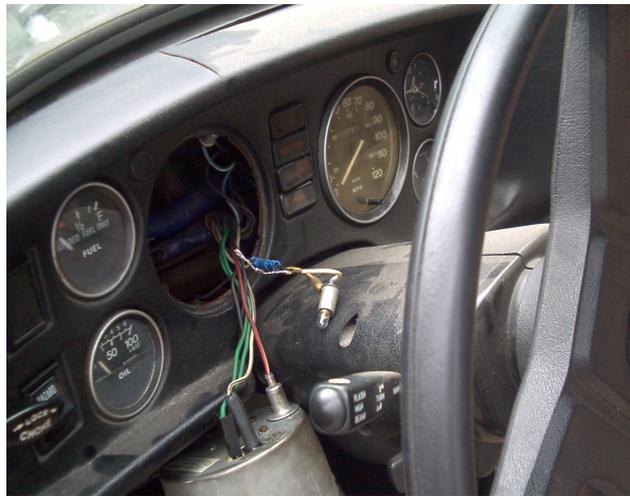
Fig. a
Diode added to warning light.

Adding diodes, or other means of repair for this are time-consuming, and if not done properly can cause diagnostic nightmares for the professional that comes along at a later date. The above example shows this clearly. If the repair shop is not aware of this added-in component, a faulty diagnosis of a charging system problem is possible.

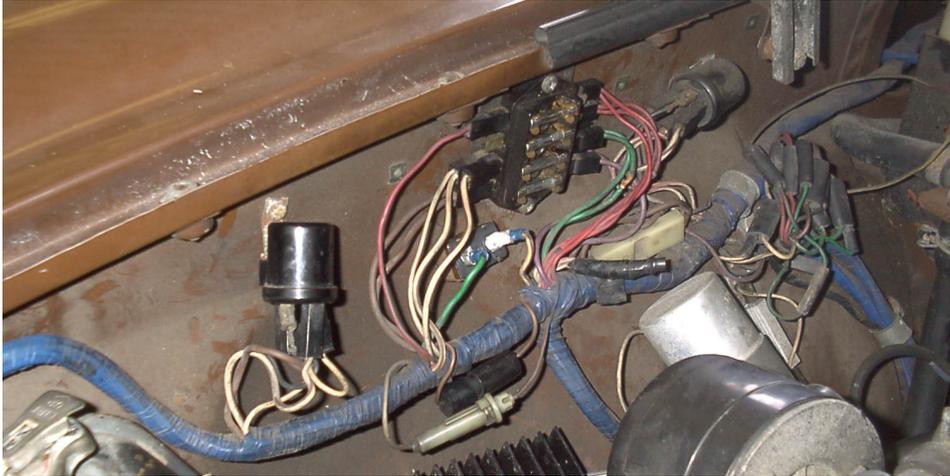
Original fuse box and ignition relay layout, 1977 MGB

It is clearly seen in the above photograph that there are three white-with-brown tracer wires on the fusebox at the second circuit from the bottom, left side. This is the circuit that feeds the “green” circuit; (wipers, turn signals, brake lights, and similar “key-on” components). Notice that the ignition relay on the left has a large white/brown wire in the center, and a small white wire at the right. The small white wire is the feed from the ignition switch. The white/brown is the output of the relay. This relay was installed for one reason only; it would reduce the load on the ignition switch of the twin electric radiator cooling fans. That is why this problem started in 1977, the first year of those fans use. However, this white/brown circuit was also used to supply power to the ignition coil, and that is where the problem starts. After shutting off the key, there is enough residual power feedback in this circuit to keep the relay from de-energizing and the coil stays live. After a few moments, this is bled off to ground through the alternator, and the relay shuts off, thus shutting off the engine.

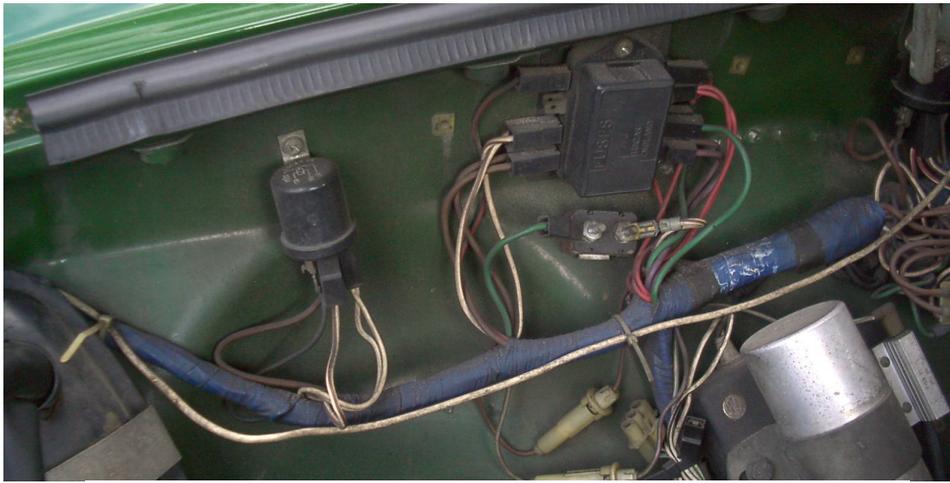
Original fuse box and ignition relay layout, 1978 and on MGB

Now you will notice that the fuse box has only two white/brown wires, and the third wire has been moved over to the ignition relay where it has been doubled up with the feed from the ignition switch, as well as had its color changed to white/no tracer. This has changed the coil supply source to be the ignition switch itself. This simple and easily accomplished change is all it takes to cure this problem.

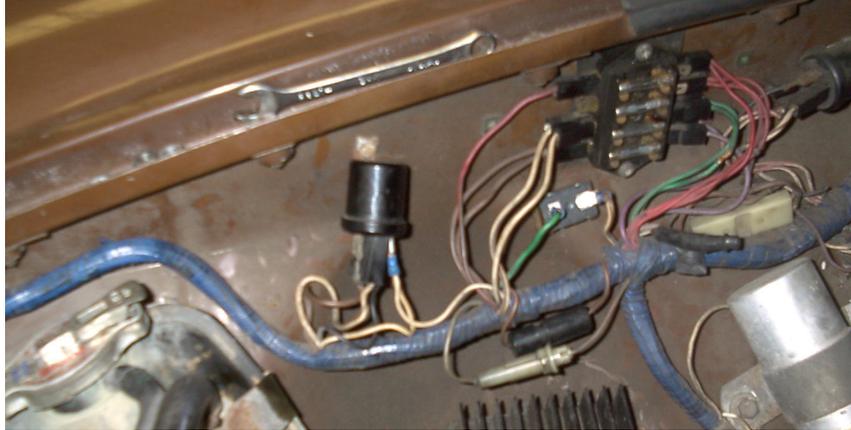
1977 MGB Fusebox after modification

One of the connectors at the fuse box has two white/brown wires incorporated in it. Simply cut the *smaller* of the doubled white/brown wires and bring it over to the relay, doubling it with the solid white wire. Quick, simple, painless. Throw away the diodes, and stop blaming Lucas.
